NTSB/AAR-02/01
PB2002-910401

Aircraft Accident Report

**Loss of Control and Impact with Pacific Ocean
Alaska Airlines Flight 261
McDonnell Douglas MD-83, N963AS
About 2.7 Miles North of
Anacapa Island, California
January 31, 2000**

**NTSB/AAR-02/01
PB2002-910401
Notation 7263E
Adopted December 30, 2002**

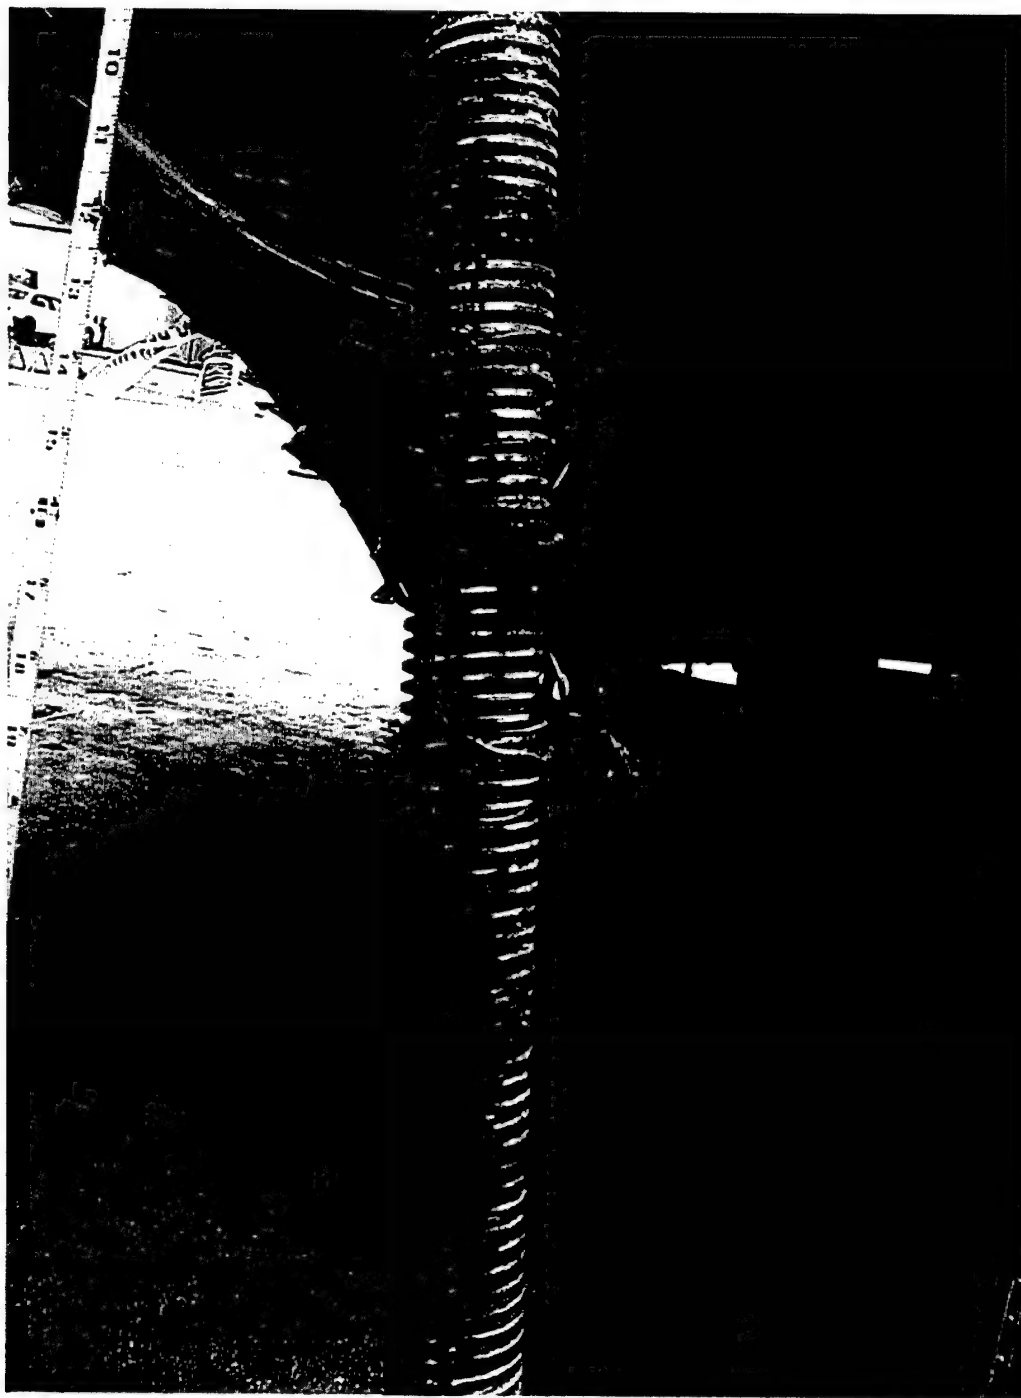
wrapped around the central part of the acme screw.¹¹⁶ (Figures 12a and 12b show the acme screw immediately after it was brought on board the recovery ship and immediately after it was brought to shore, respectively; figure 12c shows the acme screw during initial inspection.) The acme screw was rinsed with fresh water immediately after its recovery by directing the water from a hose similar to a garden hose over the gearbox and allowing the water to flow down over the screw. To preserve the acme screw and the thread remnants wrapped around the screw in their as-recovered condition, the stream of water used to rinse the screw was not directly sprayed on it. The acme screw might have been rinsed again with a garden-type hose after it was brought to shore.

Figure 12a. The acme screw immediately after it was brought on board the recovery ship.

Figure 12b. The acme screw immediately after it was brought to shore.

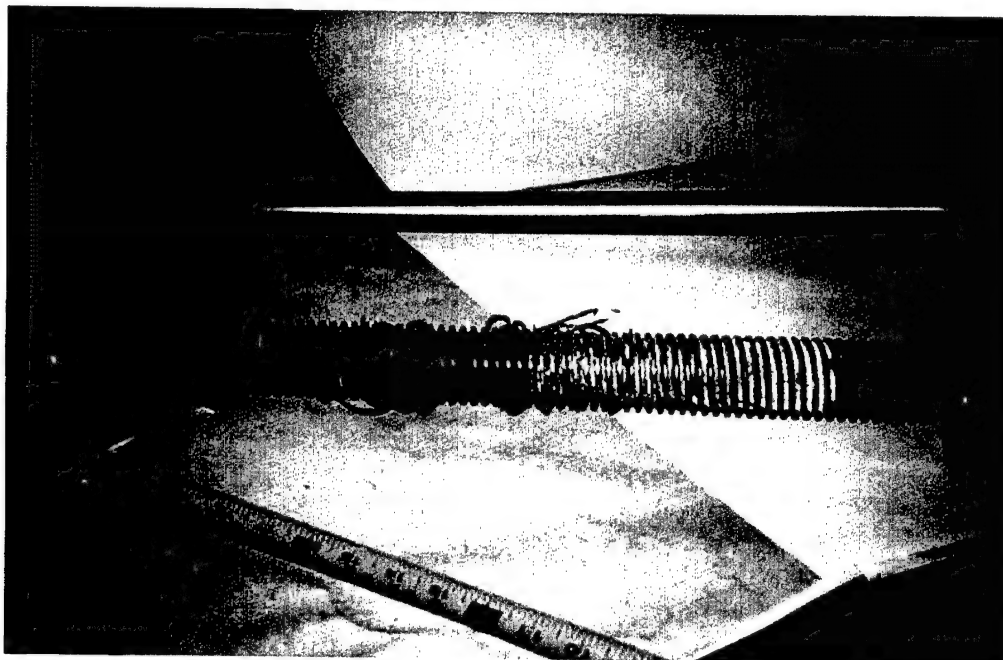
Corrosion pitting and red rust areas were found along most of the acme screw's length, with the heaviest areas of corrosion and rust along its lower half. Large areas of the acme screw were also found covered by white deposits, which chemical analysis determined were consistent with corrosion debris from the magnesium gearbox case attached to the top of the acme screw assembly. Figure 13 shows the acme screw thread remnants wrapped around the screw, the red rust areas, and the white deposits.

Figure 13. A photograph of the acme screw thread remnants wrapped around the screw, the red rust areas, and the white deposits.

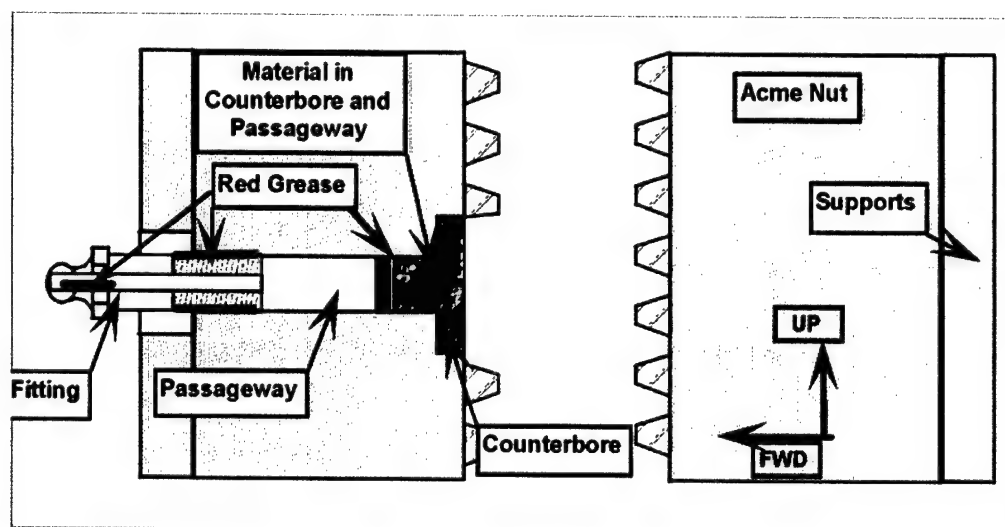
The acme nut has a grease fitting on the forward, upper side of the nut through which grease can be applied to the acme nut threads. A solid, black, claylike, dry residue coated with white, powdery material was found in the internal counterbore of the acme nut's grease passageway where it intersected the inside surface of the nut, as well as in the smaller diameter grease passageway behind the counterbore. When the grease fitting was

removed to allow collection of material samples from the grease passageway, translucent, reddish grease consistent with the appearance of Mobilgrease 28 was observed on the fitting's external threads. (Figure 17 shows a cross-section through the acme nut's grease passageway and fitting.) Traces of translucent, reddish grease were also found inside the grease passageway in the acme nut and in the bore of the grease fitting, a section distinct from the grease passageway. (Figure 18 shows the grease passageway and counterbore after the acme nut was sectioned.) Microscopic examination determined that the sample from the counterbore consisted mostly of black powdery material, larger chunks of black and white material, and particles of copper-colored metallic debris identified as acme nut material.

Figure 17. A diagram of a cross-section through the acme nut's grease passageway and fitting. Red areas denote the locations where red grease was found, and gray areas denote the location where the dry residue was found.

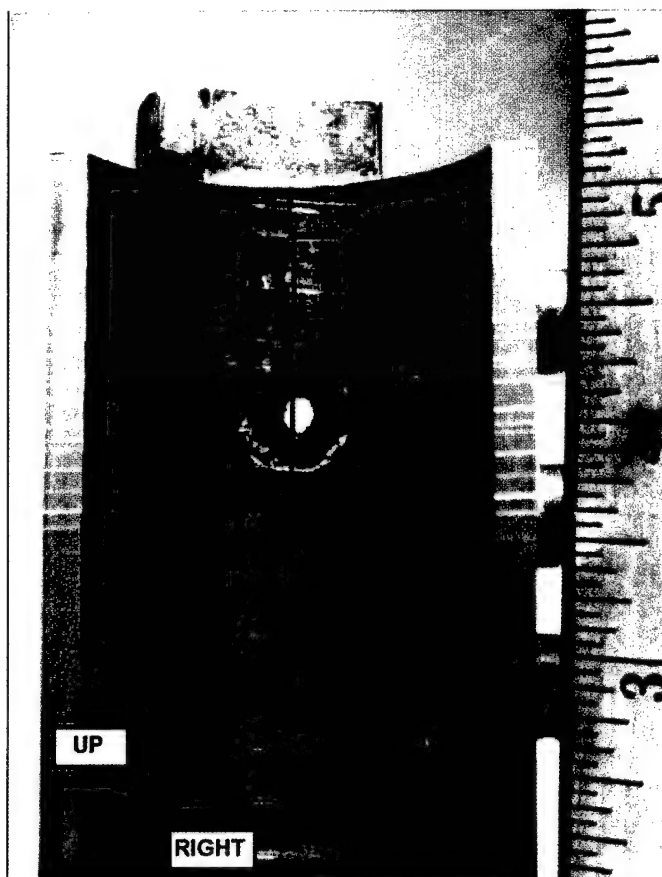
Figure 18. A photograph of the grease passageway and counterbore after the acme nut was sectioned.

Magnified visual inspections of the acme nut's interior after the nut was longitudinally sectioned confirmed the presence of the spiraling pattern consistent with the original location of the internal nut threads. For comparison with the accident acme nut interior, an exemplar nut was similarly sectioned.¹³⁶ The spiral patterns comprised a small raised ridge followed by a lustrous depression with spiral machining or wear marks transitioning into a dark band of surface deposits that rose to the next ridge. Under higher magnifications, longitudinal smearing and shear fractures were identified on the raised edges. The smearing and shearing directions were consistent with upward movement of the acme screw threads in relation to the nut body. Material was observed folded upward and smeared over adjacent surfaces along most of the ridges. Typical ridges were between 0.013 and 0.020 inch wide.

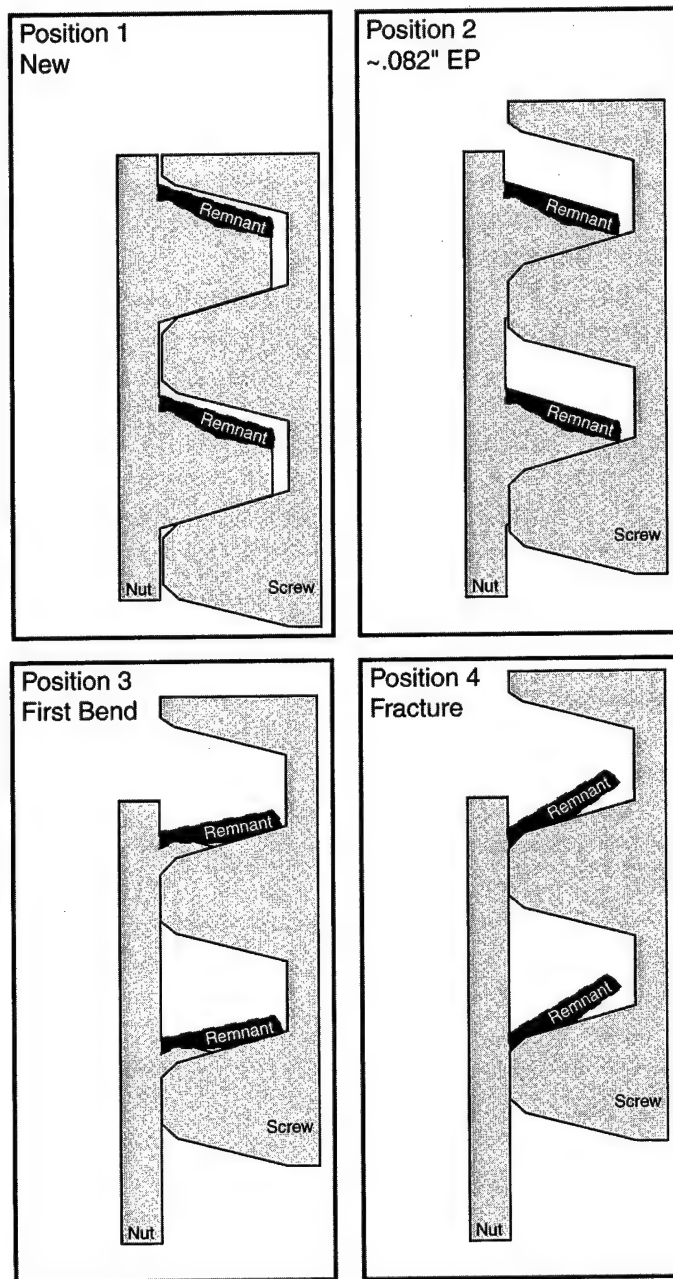
²¹⁶ It was theorized that, as the last of the acme nut thread remnants shear fractured and the screw threads tried to override the resulting ridges in the nut as the screw was pulled upward by aerodynamic loads and rotated circumferentially by the primary trim motor, the combined pinching and friction loads became greater than the combined aerodynamic and primary trim motor forces.

Figure 20. A graphical depiction of the stages of acme nut thread wear to the point of fracture.
